## Technical Service Bulletin

SUBJECT <b>AFTERMARKET WIRING AFFECTING BUS DOOR SAFETY SYSTEM</b>	REF. NO. <b>SER0018</b>
	DATE <b>13/10/2025</b>
MODELS <b>OPTIMUS &amp; ENDURA WITH SCANIA, MAN, OR MERCEDES BENZ CHASSIS</b>	REV. <b>A</b>

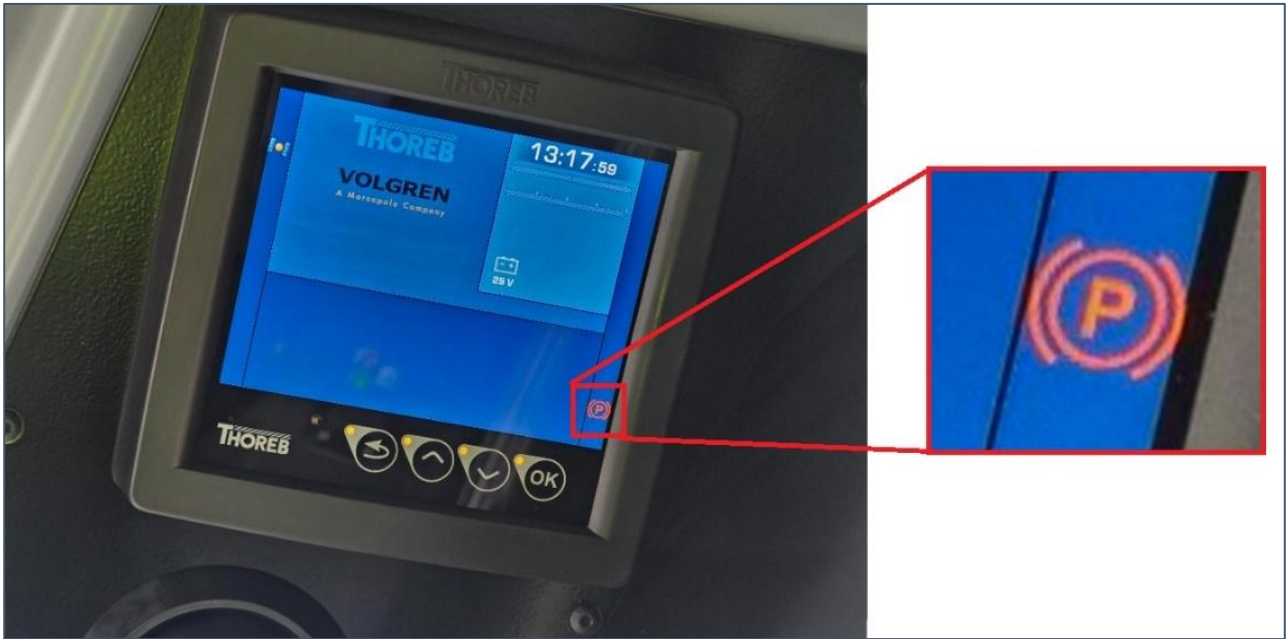
- Start up the vehicle in a safe and appropriate location (e.g. the bus depot) and bring it to normal operating conditions.
- Whilst the vehicle is stationary, activate and release the park brake 3 times and monitor if the *park brake ON* symbol shows on both the C90 display (**Figure 1**) as well as the vehicle dash instrument cluster.
- If the *park brake ON* symbol is permanently shown on the C90 display regardless of whether the park brake is activated or released, then it is likely that the park brake signal has been compromised and requires immediate rectification.
- If immediate rectification is required, the vehicle should not be used and should remain in a safe and appropriate location until the issue is resolved.

Figure 1 – C90 display and park brake ON symbol

If the vehicle is also fitted with a C90 display, a pop-up warning message will also be shown on screen (**Figure 14**).

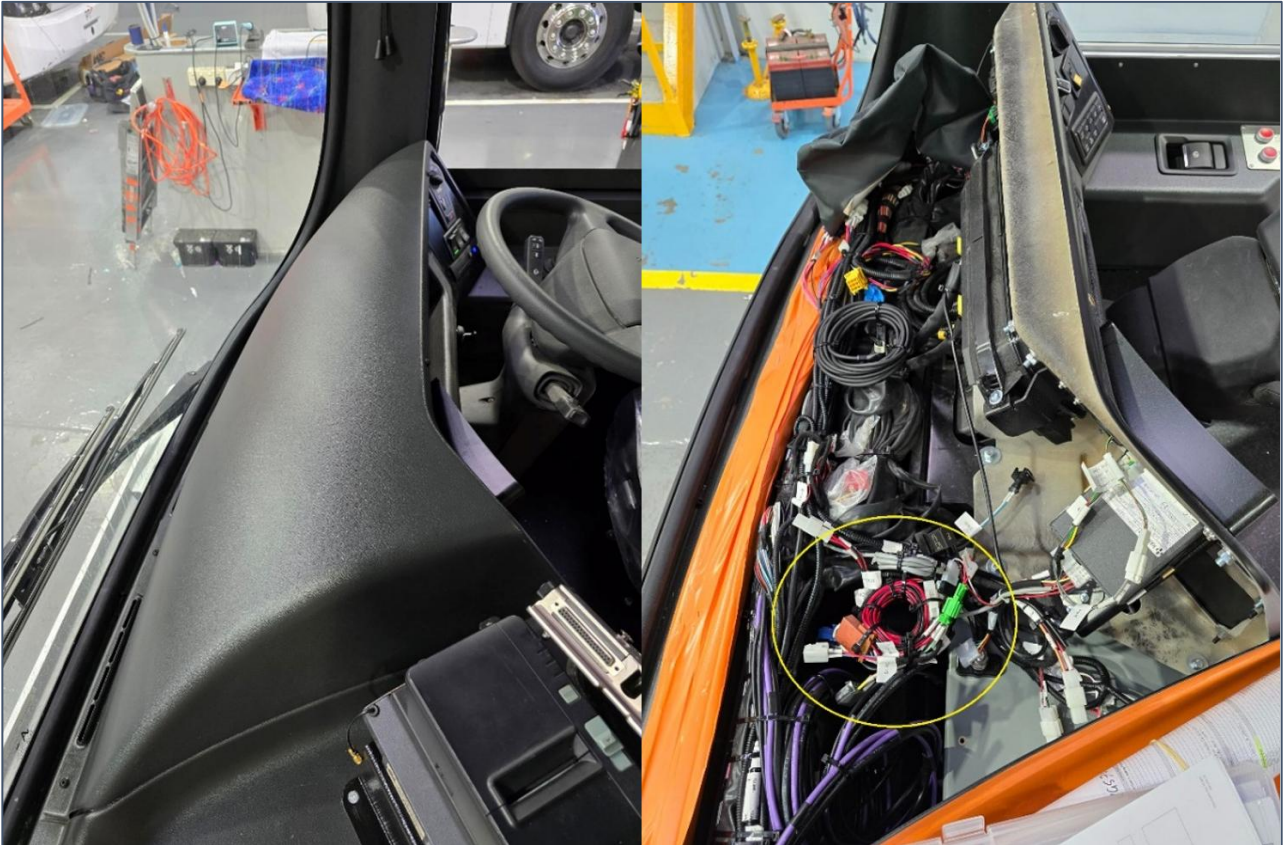
### 2.1.3 Connector S1305

This connector is for Volgren applications only. It is located behind the dash binnacle cover as shown in **Figure 4**. Please remove the dash binnacle cover and inspect connector *S1305* to make sure no other wiring or connections are mated to it. The OEM connector should look intact as per **Figure 5**. If connector *S1305* appears modified or additional aftermarket wiring is connected to it, the park brake signal could be or become compromised.

Figure 4 – Dash binnacle cover and location of connector S1305

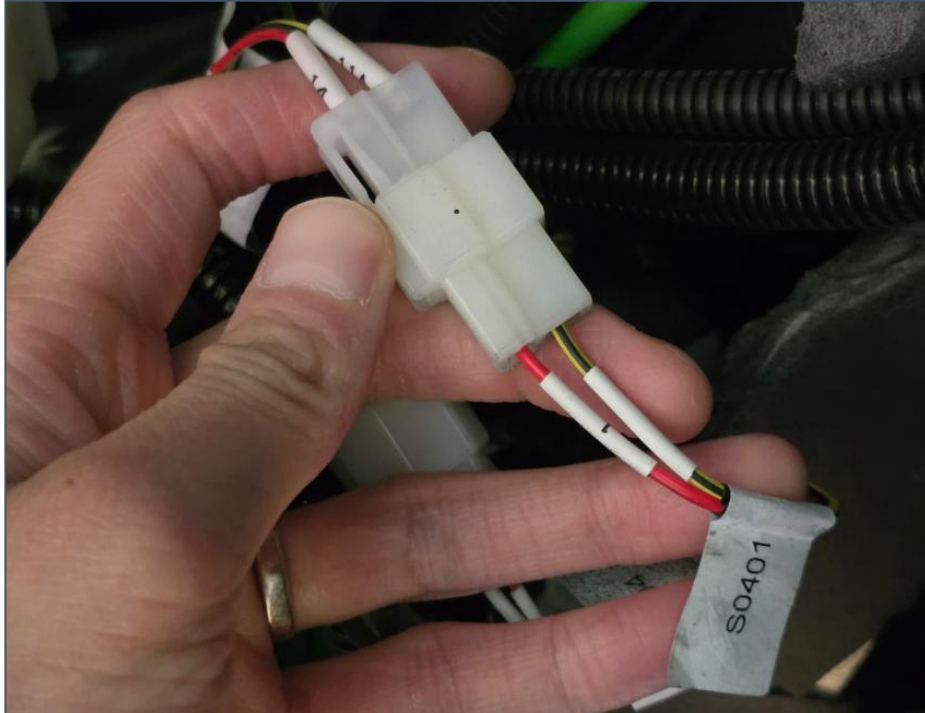
These are interface connectors for the external front door open/close (green) button. *S0401* is located above the LHS B-Pillar in the overhead compartment (**Figure 6**), and *S0401-1* is located adjacent to the front door's external open/close push button usually underneath or behind the hinged side panel (**Figure 7**). They should be tied up, mated and fully seated with no obvious modifications like wire splicing or mismatched wire colours.

Figure 6 – Connector S0401 above the LHS B-Pillar in the overhead compartment

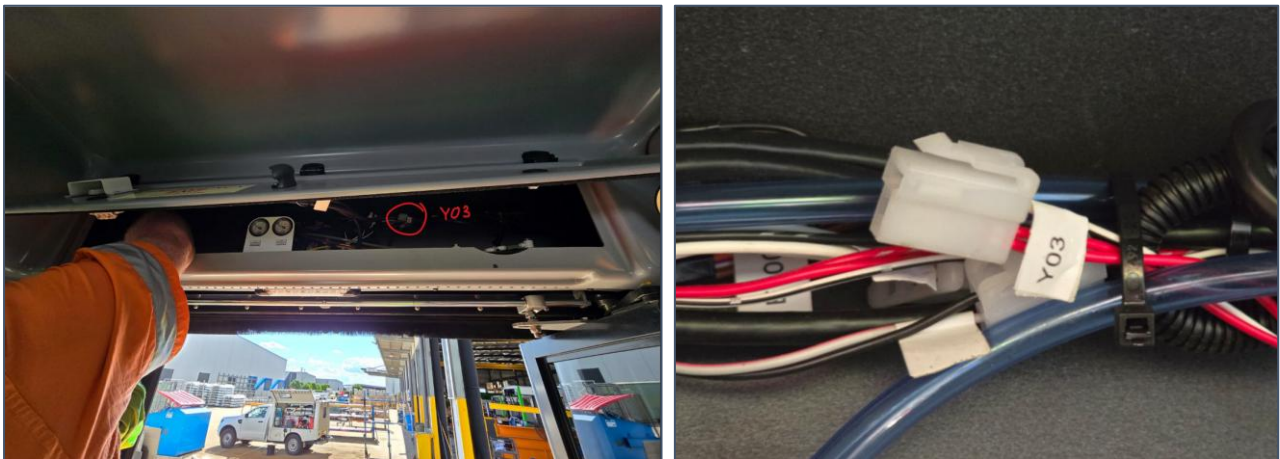
Y03 is located above the front door behind the door mechanism cover (**Figure 9**), and Y03-1 is located above the RHS B-Pillar in the overhead compartment. They should be tied up with no obvious modifications like wire splicing or mis-matched wire colours.

Figure 9 – Connector Y03 behind the front door mechanism cover

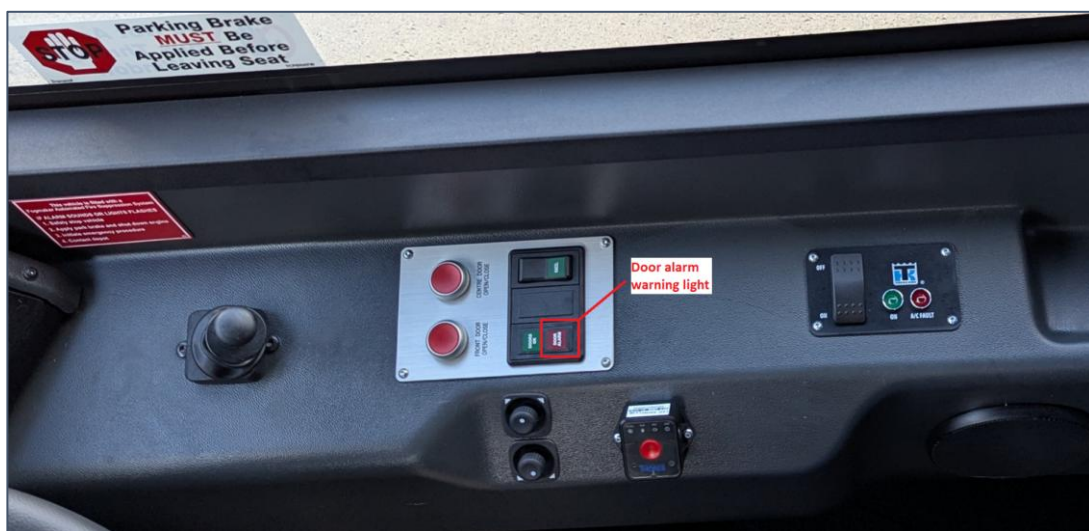
The update will activate the *door alarm warning light* and *buzzer* if the door safety system detects an errant park brake signal while the vehicle speed is over 5km/h. (**Figure 13** for Optimus, and **Figure 2** for Endura.)

Figure 13 – Door alarm warning light on driver's side console on Optimus

Volgren also strongly recommends installing our latest multiplex software update which includes an additional alert to the driver if an errant park brake signal is detected.

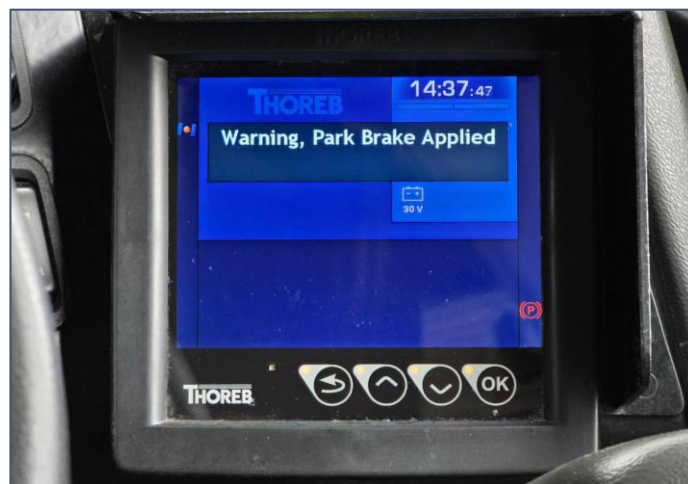
Figure 14 – C90 park brake warning message
